## CURING DC-TO-DC-CONVERTER SPURS IN THE DRAKE TR-7 TRANSCEIVER

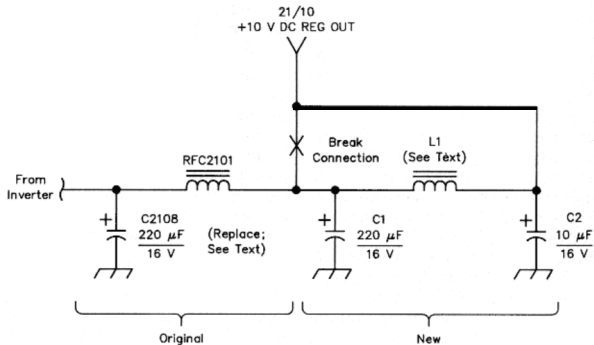
In my case, the spurs registered S5 on the TR-7's S meter, while the 25-kHz markers came in at 15 dB over S9. This "multi-channel" response degraded my TR-7's ability to receive weak signals. On trans-

Replacing C2108, a dc-to-dc-converter decoupling capacitor on the transceiver's internal power-supply circuit board (Fig 2-23 in *the TR-7 Maintenance Manual*), reduced the spurs to S2. This is acceptable, but adding another pi filter section in cascade with RFC2101/C2108 (Fig 2) pushed the spurs into the noise.

Fig 2-Mike Agsten reduced dc-to-dc-converter-related TR-7 spurs by replacing the rig's C2108 and adding three filter components (C1, C2 and L1) as shown here. L1 consists of no. 24 enameled wire wound to fill a junk-box 1/2-inch-OD ferrite toroid.

There's plenty of room on the back of the power-supply board to "kludge in" the new parts. The added filter inductor (L 1 in Fig 2) is a junk-box 1/2-inch-OD ferrite toroid filled with no. 24 enameled copper wire.-Mike *Agsten, WA8TXT, 405 W Rd, Sandusky, OH 44870*
